Docket No. 217 – Development and Management Plan Inspection

Northeast Utilities Service Company Certificate of Environmental Compatibility and Public Need for the construction of a 345-kV electric transmission line and reconstruction of an existing 115-kV electric transmission line between Connecticut Light and Power Company's Plumtree Substation in Bethel, through the towns of Redding, Weston, and Wilton, and to the Norwalk Substation in Norwalk, Connecticut.

Date: October 25, 2006

Location: 115 kV Underground Route

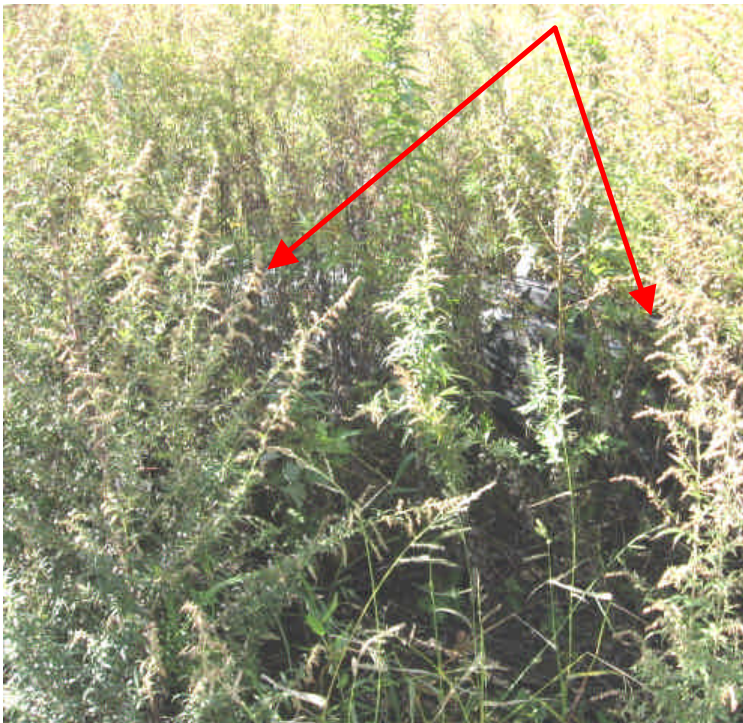
- Silt fence was also noted here along the river, approximately 5 feet into the tall vegetation. 10/18-10/25/06
 - Remove remaining silt fence in this location when all adjacent areas are temporarily stabilized. 10/25/06

Photo on the left shows silt fence remaining within the vegetation along the Broad St section of the ROW, north of Norwalk Substation. Remove when feasible and when adjacent areas are mulched. Photo on the right shows silt fence debris that should also be removed from under the soil when repairs are made to the asphalt. (This may occur as work under another section of the project.) 10/25/06

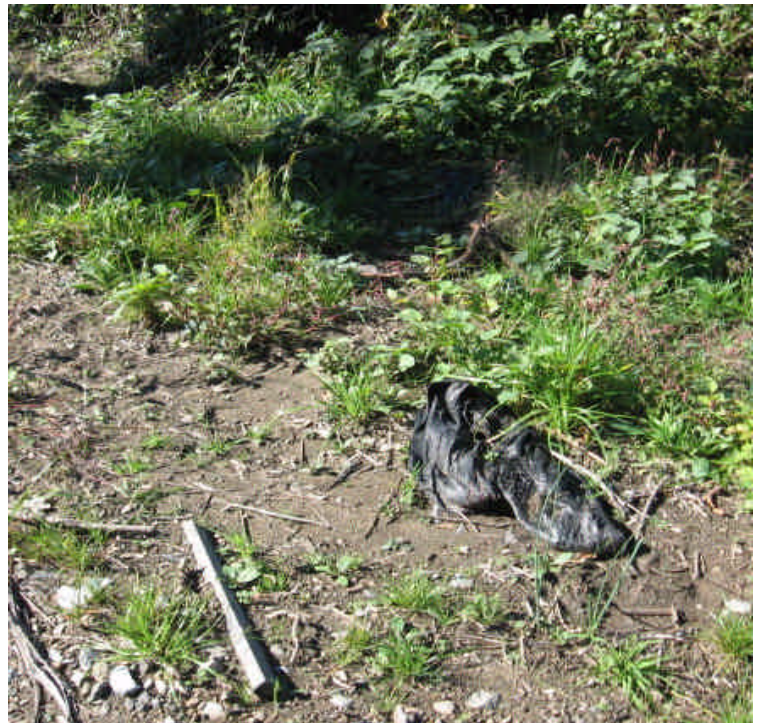
- Area can be removed from inspection.
- At Broad St, north of Norwalk Substation, minor silt fence debris is still noted along the bike path, under the restored soil areas. Contractor stated that previous efforts had been made to remove this but debris remains. 9/13-10/25/06

- Remove the debris as feasible (Aesthetic, not environmental issue) and temporarily stabilize areas adjacent to the bike path with mulch or similar. 9/13-10/25/06

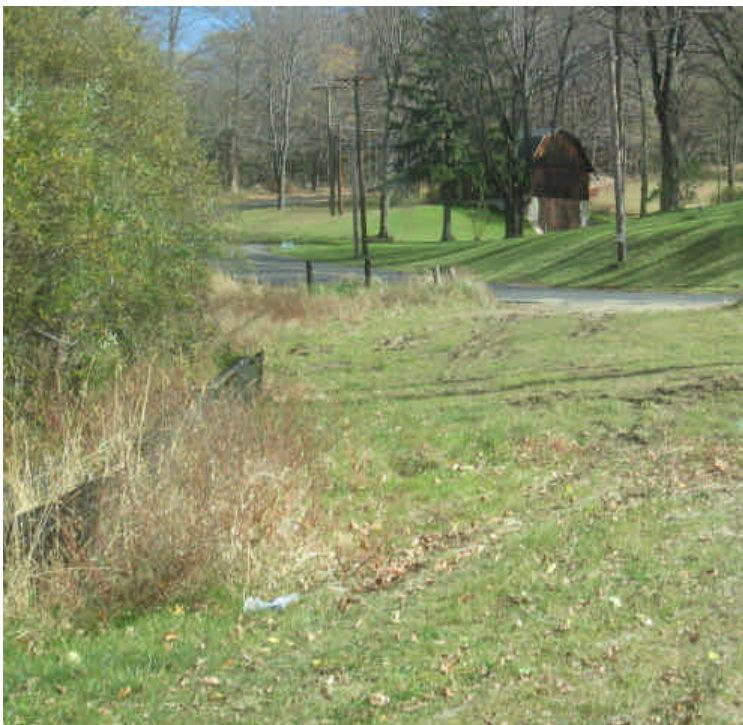
Photo on the left shows the Sunset Hill Rd. previous storage area. Silt fence should be removed here. Photo on the right shows the minor grass growth at the Redding CC storage area. This area is temporarily stable as further cover is not expected. 10/25/06

- The Sunset Hill Rd. previous storage area is stabilized with vegetation. 10/18-10/25/06
 - Remove all remaining silt fence at this location.
- The Redding Country Club previous storage area had some minor grass growth but is temporarily stabilized. No additional growth is expected prior to the winter. 10/25/06
